**Flood Control Project Maintenance
Levee Inspections**
LMA District Cover Sheet
Spring 2017 Levee Inspection Results

American River Flood Control District

Spring 2017 Levee Inspection Results

Waterway			Bank	Unit Miles
Unit No. 01 Arcade Creek			Left	2.08
	Spring (March - May)	Summer (June - August)	(September - November) Fall	Winter (December - February)
Unit Maintenance Rating (Fall Only)				
Date of Inspection	3/15/2017 - 5/3/2017			
DWR Inspector	Maksim Khashchuk			
Accompanied By	Ross Kawamura ARFCD

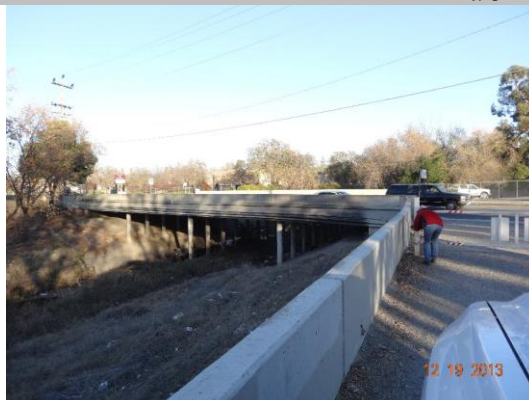
Photo 1 of 2 : UCIP_SP_2017_31424_57481.jpg

LM Start	2.08	Rating **	M	Issue No.	194
LM End	2.08	Issue Type +	En	Location *	LS
Category	Supplemental			GPS Latitude/Longitude	
				Start	End
Item	DWR UCIP Field Study			38.627242 °	38.627242 °
				-121.432469 °	-121.432469 °
DWR ID					
Comment Code					
Inspector Comment					
FS_ID:31424					
DS_ID:24797					
EP_NO: N/A					
Repair Type: Non-Urgent					
Crossing Status: Found					
UCIP Comments: no permit--need to determine additional information and owner of crossings.					
FIELD_STRUCT_DESC: 1-4 inch conduit and 1-2 inch communication cable through levee. Conduits are suspended through waterway and attached to downstream face of bridge.					
FS Date: 12/19/2013

View of waterward side--conduits visible on bridge face.

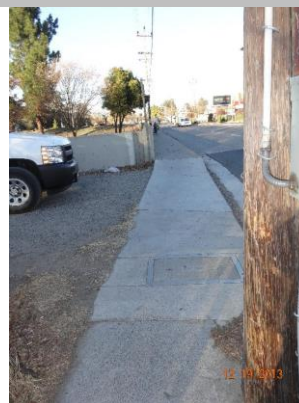
Photo 2 of 2 : UCIP_SP_2017_31424_57480.jpg

Service box located on sidewalk unable to determine if box belongs to conduits.

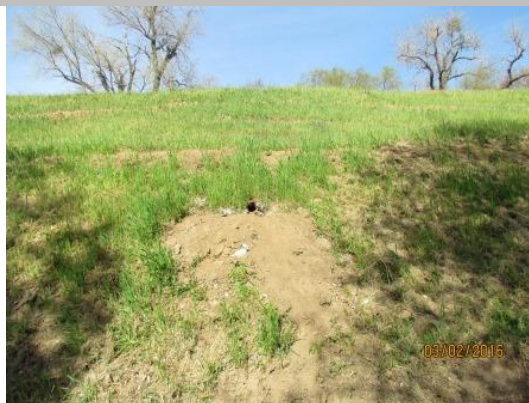
Photo 1 of 2 : SP_2017_NA0001_52_28_20170313_00008.jpg

LM Start	0.09	Rating **	A/W	Issue No.	28
LM End	0.10	Issue Type +	Ma	Location *	LS
Category	Earthen Levee			GPS Latitude/Longitude	
				Start	End
Item	Animal Control			38.603765 °	38.603878 °
				-121.471642 °	-121.471448 °
DWR ID	DWR_NA0001_02_f_2015_28				
Comment Code					
Inspector Comment					
LMA backfilled the holes. This area should be monitored for future rodent activity.

View of the rodent holes on the landside levee slope.

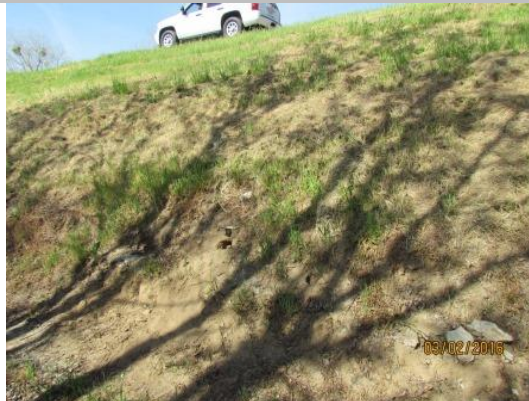
Photo 2 of 2 : SP_2017_NA0001_52_28_20170313_00009.jpg

Another view of the rodent holes on the landside levee slope.

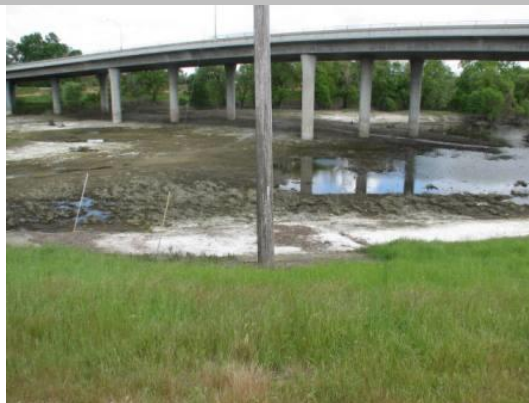
Photo 1 of 1 : SP_2017_NA0001_52_2_20170313_00001.jpg

LM Start	0.33	Rating **	M	Issue No.	2
LM End	0.33	Issue Type +	En	Location *	WS
Category	Earthen Levee			GPS Latitude/Longitude	
				Start	End
Item	Encroachments			38.605822 °	38.605822 °
				-121.468078 °	-121.468078 °
DWR ID	DWR_NA0001_02_s_2012_2				
Comment Code					
PO : Pole					
Inspector Comment					
Power pole in levee

04/13/2011 Power pole is in the levee on the water side.

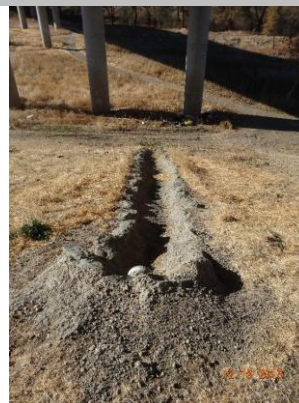
Photo 1 of 3 : UCIP_SP_2017_31443_57484.jpg

LM Start	0.36	Rating **	M	Issue No.	151
LM End	0.36	Issue Type +	En	Location *	WS
Category	Supplemental			GPS Latitude/Longitude	
				Start	End
Item	DWR UCIP Field Study			38.606204 °	38.606204 °
				-121.467817 °	-121.467817 °
DWR ID					
Comment Code					
Inspector Comment					
FS_ID:31443 DS_ID:24798 EP_NO: N/A Repair Type: Non-Urgent Crossing Status: Indicator Found UCIP Comments: no permit (unauthorize crossing)--need to determine additional information about crossing. Unable to determine if pipe crosses levee. FIELD_STRUCT_DESC: 4-inch HDPE pipe through levee at unknown depth. FS Date: 12/6/2013

View of waterward slope.

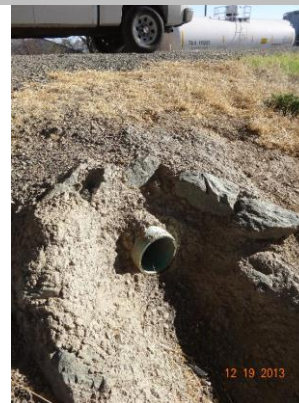
Photo 2 of 3 : UCIP_SP_2017_31443_57483.jpg

LM Start	0.36	Rating **	M	Issue No.	151 (cont)	
LM End	0.36	Issue Type +	En	Location *	WS	
Category	Supplemental			GPS Latitude/Longitude		
				Start	End	
Item	DWR UCIP Field Study			38.606204 °	38.606204 °	
				-121.467817 °	-121.467817 °	
DWR ID						
Comment Code						
Inspector Comment						
FS_ID:31443						
DS_ID:24798						
EP_NO: N/A						
Repair Type: Non-Urgent						
Crossing Status: Indicator Found						
UCIP Comments: no permit (unauthorize crossing)--need to determine additional information about crossing. Unable to determine if pipe crosses levee.						
FIELD_STRUCT_DESC: 4-inch HDPE pipe through levee at unknown depth.						
FS Date: 12/6/2013

View of pipe through levee.

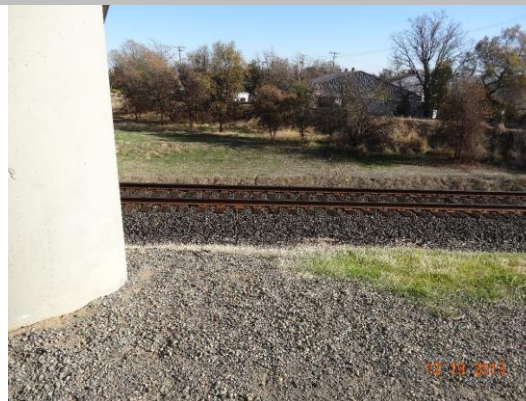
Photo 3 of 3 : UCIP_SP_2017_31443_57482.jpg

View of landward side.

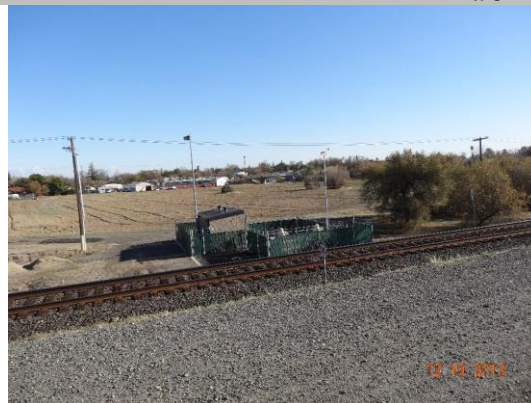
Photo 1 of 3 : UCIP_SP_2017_49533_55042.jpg

UCIP Comments: 08/29/2016 Facility details confirmed by the City of Sacramento only one 36-inch WSP goes through levee at this location. Ownership in the CVFPB records still shows ARFCD. Efforts to update CVFPB records are in-progress, owner of this facility is the City of Sacramento. Need to coordinate with ARFCD and City of Sacramento to determine the fate of Pump Station 3. (DWR UCIP - Olivia M)12/19/2013 Need to determine the status of crossing. Unable to confirm if crossing found in field corresponds to this entry.

View of landward side--pump station with multiple pumps.

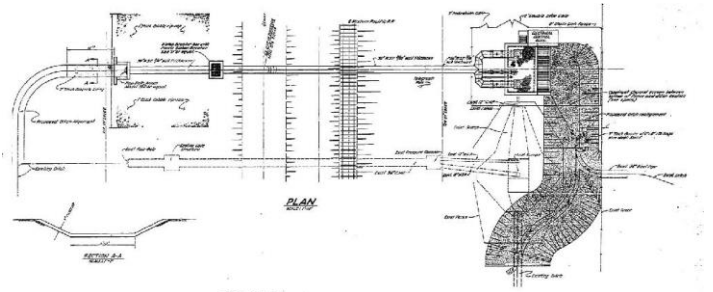
Photo 2 of 2 : UCIP_SP_2017_51428_75578.jpg

FS_ID:51428
DS_ID:24612
EP_NO: N/A
Repair Type: Non-Urgent
Crossing Status: Not Found
UCIP Comments: 08/29/2016 Facility details confirmed by the City of Sacramento. This crossing was an existing pipe that was mentioned in Permit No. 6064 and 6064-A under the following conditions: Thirteen: "that the existing 36-inch diameter corrugated metal pipe shall be allowed to remain in place for a period of 10 years, (until May 1978), at which time if the old pumping plant has not been used the pipe through the levee shall be removed by the applicant." and Fifteen: "That the existing 36-inch pipe shall be properly capped or sealed on both ends. Need to coordinate with the City of Sacramento and ARFCD to determine the fate of this crossing. Application No. 6064 references U.S. Corps of Engineers Stat. 217+00 as Pump Plant No. 3. (DWR UCIP - O. Magana)12/19/2013 Multiple pumps visible on landward side however unable to confirm additional crossings. Only 1 crossing was found at this location. (DWR UCIP - O. Magana)

Sump 153 Plan and Profile, existing Pump Plant No. 3 referenced.

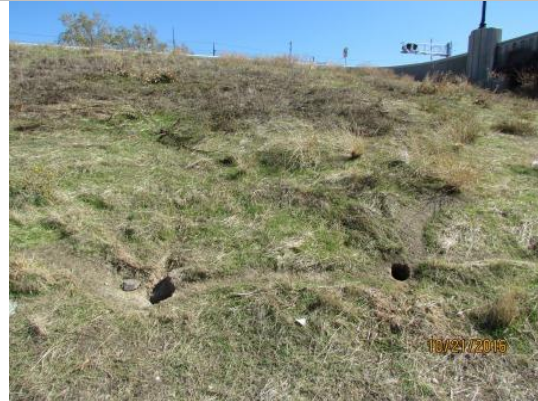
Photo 1 of 1 : SP_2017_NA0001_52_24_20170313_00004.jpg

LM Start	0.73	Rating **	M	Issue No.	24
LM End	0.73	Issue Type +	Ma	Location *	WS
Category	Earthen Levee			GPS Latitude/Longitude	
				Start	End
Item	Animal Control			38.611529 °	38.611529 °
				-121.466801 °	-121.466801 °
DWR ID	DWR_NA0001_02_s_2016_24				
Comment Code					
A1 : Exterminate rodents and backfill and compact or grout burrows.					
Inspector Comment					
Rodents still active in this area.

View of the rodent holes in the waterside levee slope.

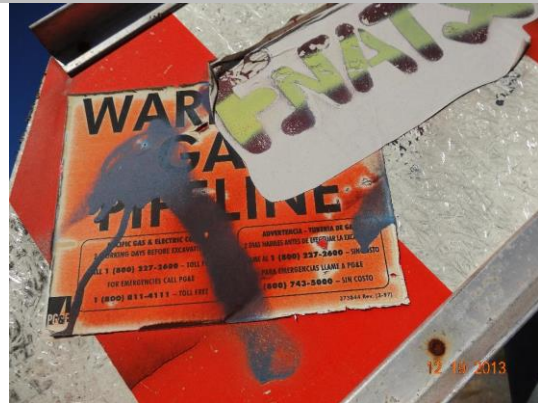
Photo 2 of 3 : UCIP_SP_2017_42132_55453.jpg

FS_ID:42132
DS_ID:24613
EP_NO: 2347
Repair Type: Non-Urgent
Crossing Status: Indicator Found
UCIP Comments: 11/3/2014 (DWR-Olivia) Need to contact owner to determine status of crossing. Priority under Part IX has been changed from Urgent to Non-Urgent as a measure to normalize the data. Markers present however unable to confirm pipe size. Recommend LMA to contact owner to determine additional information details--confirm pipe size, alignment, and last inspection completed confirming integrity of crossing. Need to contact owner to determine status of crossing. Unable to confirm if indicators visible on levee crown and landward side correspond to this crossing.
FIELD_STRUCT_DESC: 6-inch gas line through the levee, 2.5 feet below the crown. For emergencies contact PG&E at 1-800-811-411. (Permit No. 2347-1957)
FS Date: 12/19/2013

Contact information for owner--sign visible on waterward side slope.

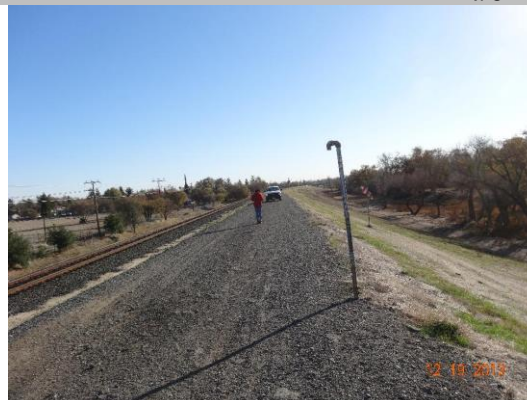
Photo 1 of 3 : UCIP_SP_2017_42130_52766.jpg

Comment Code					
Inspector Comment					
FS_ID:42130 DS_ID:24277 EP_NO: 2333 Repair Type: Non-Urgent Crossing Status: Indicator Found UCIP Comments: 11/3/2014 (DWR-Olivia) Need to contact owner to determine status of crossing. Priority under Part IX has been changed from Urgent to Non-Urgent as a measure to normalize the data. Markers present however unable to confirm pipe size. Recommend LMA to contact owner to determine additional information details--confirm pipe size, alignment, and last inspection completed confirming integrity of crossing.Need to contact owner to determine status of crossing. Unable to confirm if indicators visible on levee crown and landward side correspond to this crossing. FIELD_STRUCT_DESC: 12-inch gas line through the levee, 3.0 feet below the crown. For emergencies contact PG&E at 1-800-811-4111. (Permit No. 2333-1957) FS Date: 12/19/2013

Overview of levee crown at crossings.

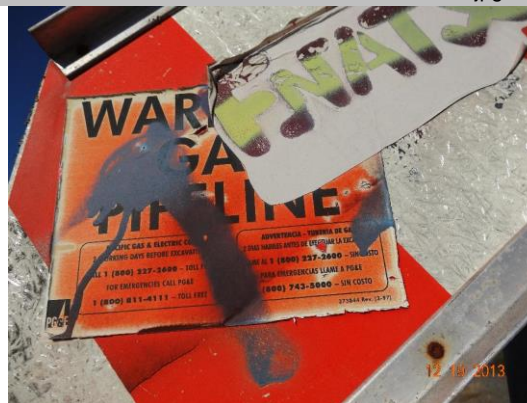
Photo 2 of 3 : UCIP_SP_2017_42130_52768.jpg

Marker with emergency contact information located on waterward slope.

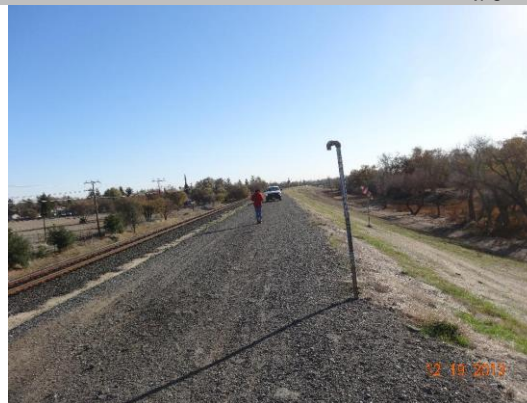
Photo 1 of 3 : UCIP_SP_2017_28666_52778.jpg

LM Start	1.03	Rating **	M	Issue No.	156
LM End	1.03	Issue Type +	En	Location *	WS
Category	Supplemental			GPS Latitude/Longitude	
				Start	End
Item	DWR UCIP Field Study			38.615772 °	38.615772 °
				-121.466971 °	-121.466971 °
DWR ID					
Comment Code					
Inspector Comment					
FS_ID:28666 DS_ID:24614 EP_NO: 1949 Repair Type: Non-Urgent Crossing Status: Indicator Found UCIP Comments: Need to contact owner to determine if pipe was left inside levee as part of abandonment process. FIELD_STRUCT_DESC: *Abandoned* 12-inch steel gas line through the levee, 3.0 feet below the crown. Pipe grout filled. Concrete cutoff wall around pipe under center of levee. (Permit No. 1450-1949) This entry matches the Drainage or Irrigation Structure referenced in O&M manual (Station 243+31). Pipe abandoned under Permit No. 17468 (2004). FS Date: 12/19/2013

Overview of levee crown at crossings.

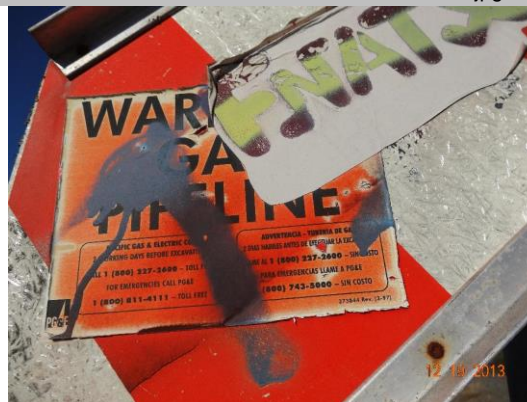
Photo 2 of 3 : UCIP_SP_2017_28666_52780.jpg

Marker with emergency contact information located on waterward slope.

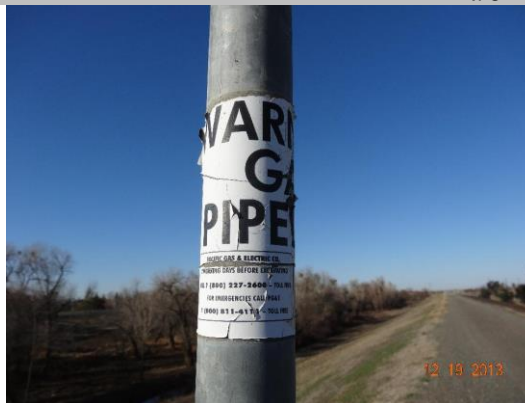
Photo 3 of 3 : UCIP_SP_2017_28666_52779.jpg

LM Start	1.03	Rating **	M	Issue No.	156 (cont)
LM End	1.03	Issue Type +	En	Location *	WS
Category	Supplemental			GPS Latitude/Longitude	
				Start	End
Item	DWR UCIP Field Study			38.615772 °	38.615772 °
				-121.466971 °	-121.466971 °
DWR ID					
Comment Code					
Inspector Comment					
FS_ID:28666 DS_ID:24614 EP_NO: 1949 Repair Type: Non-Urgent Crossing Status: Indicator Found UCIP Comments: Need to contact owner to determine if pipe was left inside levee as part of abandonment process. FIELD_STRUCT_DESC: *Abandoned* 12-inch steel gas line through the levee, 3.0 feet below the crown. Pipe grout filled. Concrete cutoff wall around pipe under center of levee. (Permit No. 1450-1949) This entry matches the Drainage or Irrigation Structure referenced in O&M manual (Station 243+31). Pipe abandoned under Permit No. 17468 (2004). FS Date: 12/19/2013

Marker located on the waterward side.

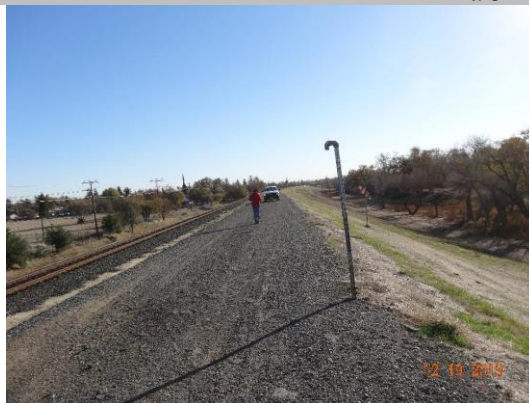
Photo 1 of 3 : UCIP_SP_2017_42131_52772.jpg

Comment Code					
Inspector Comment					
FS_ID:42131 DS_ID:24280 EP_NO: 17468 Repair Type: Non-Urgent Crossing Status: Indicator Found UCIP Comments: 11/3/2014 (DWR-Olivia) Need to contact owner to determine status of crossing. Priority under Part IX has been changed from Urgent to Non-Urgent as a measure to normalize the data. Markers present however unable to confirm pipe size. Recommend LMA to contact owner to determine additional information details--confirm pipe size, alignment, and last inspection completed confirming integrity of crossing.Need to contact owner to determine status of crossing. Unable to confirm if indicators visible on levee crown and landward side correspond to this crossing. FIELD_STRUCT_DESC: 20-inch steel gas pipe through the levee, approximately 86.0 feet below the crown. For emergencies contact PG&E at 1-800-811-4111. (Permit No. 17468-2004) FS Date: 12/19/2013

Overview of levee crown looking downstream at signs of crossings.

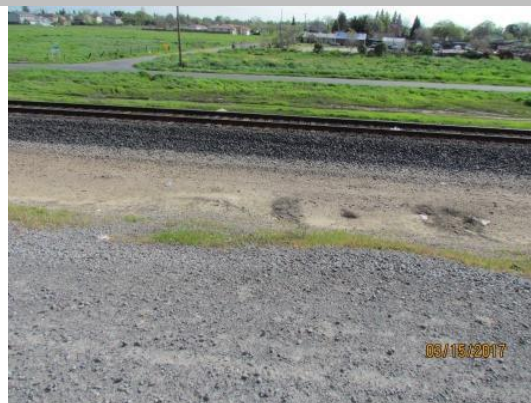
Photo 1 of 2 : SP_2017_NA0001_52_150_20170327_00041.jpg

LM Start	2.33	Rating **	A/W	Issue No.	150
LM End	2.33	Issue Type +	Ob	Location *	LS
Category	Earthen Levee			GPS Latitude/Longitude	
				Start	End
Item	Erosion / Bank Caving			38.634446 °	38.634446 °
				-121.470573 °	-121.470573 °
DWR ID	DWR_NA0001_02_s_2012_150				
Comment Code					
E1 : Note and monitor erosion site.					
Inspector Comment					
Monitor erosion at this location. Also noted in USACE PI.

Spring 2017 - View of the depression, the issue has not gotten any worse since the fall 2011 inspection.

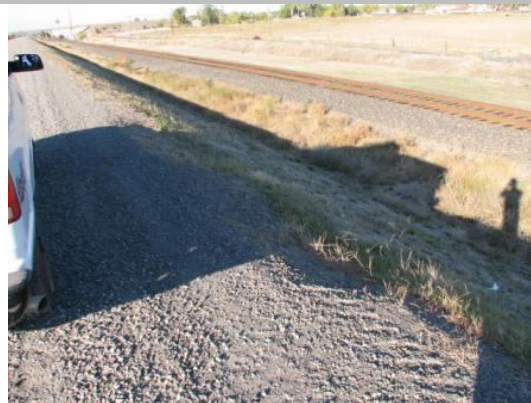
Photo 2 of 2 : SP_2017_NA0001_52_150_20170313_00011.jpg

11/16/2011 Depressions present on levee slope.

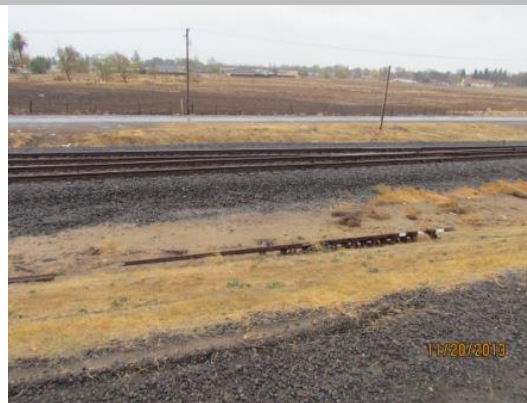
Photo 1 of 1 : SP_2017_NA0001_52_11_20170313_00003.jpg

LM Start	2.52	Rating **	M	Issue No.	11
LM End	2.52	Issue Type +	En	Location *	LS
Category	Earthen Levee			GPS Latitude/Longitude	
				Start	End
Item	Encroachments			38.637177 °	38.637177 °
				-121.471076 °	-121.471076 °
DWR ID	DWR_NA0001_02_f_2013_11				
Comment Code					
MA : Material					
Inspector Comment					
Railroad rails on landside levee slope.

View of the rails at the landside levee toe.

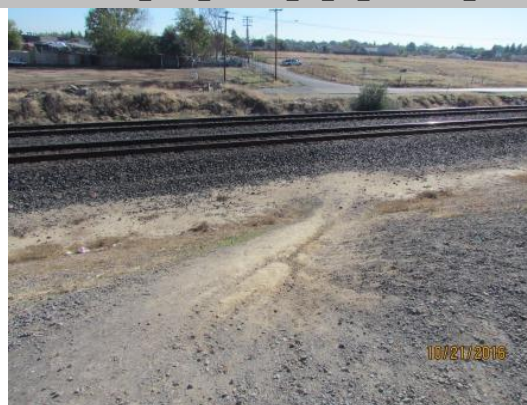
Photo 1 of 1 : SP_2017_NA0001_52_27_20170313_00007.jpg

LM Start	2.59	Rating **	M	Issue No.	27
LM End	2.59	Issue Type +	Ma	Location *	LS
Category	Earthen Levee			GPS Latitude/Longitude	
				Start	End
Item	Slope Stability			38.638109°	38.638109°
				-121.471254°	-121.471254°
DWR ID	DWR_NA0001_02_f_2016_27				
Comment Code					
S2 : Repair the levee slope damaged by foot traffic and prevent access where possible.					
Inspector Comment

View of the foot path on the landside levee slope.

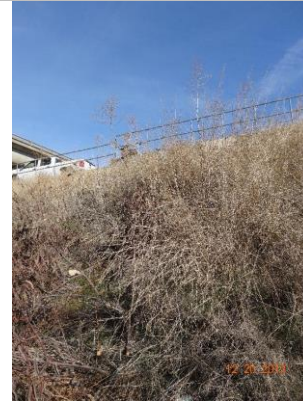
Photo 3 of 3 : UCIP_SP_2017_49862_52894.jpg

Item	DWR UCIP Field Study			38.640988 °		38.640988 °
				-121.471797 °		-121.471797 °
DWR ID						
Comment Code						
Inspector Comment						
FS_ID:49862 DS_ID:24608 EP_NO: 9596 Repair Type: Non-Urgent Crossing Status: Indicator Found UCIP Comments: Dense vegetation on waterward side limits inspector's inspection. Recommend removing vegetation. FIELD_STRUCT_DESC: [Sump No. 157] 1 of 3: 54-inch steel drainage pipe through the levee, 3 feet below the crown. Steel cutoff wall around pipe under center of levee. Siphon breaker in protective housing located on the waterside (WS) shoulder. Concrete headwall and flap gate located on the WS end. Trench on WS. Pumping plant located on the landside (LS). On March 28, 1995, the Sacramento City Council adopted Resolution No. 95-123 authorizing the execution of Agreement No. 95-065 regarding the transfer of drainage facilities that include Pump Station 7 as described by ARFCD and described by the City of Sacramento as Sump 157. (three 54-inch pipes installed in the siphon breaker structure but only one pipe installed through levee under Permit No. 9596, 9596-A, and 1975 - American River Flood Control District; second pipe installed through levee under Permit No. 9596-B, 1980 - American River Flood Control District; name change completed under Permit 9596-1 (includes work authorized under Permit No. 9596, 9596-A, and 9596-B), 2016 - City of Sacramento) [Additional Reference(s): DWR Levee Log, 2002] FS Date: 12/20/2013

Dense vegetation located on waterward slope.

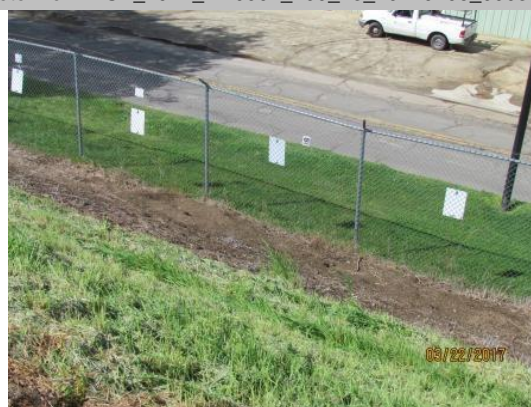
Photo 1 of 1 : SP_2017_NA0001_490_23_20170406_00035.jpg

LM Start	0.81	Rating **	M	Issue No.	23
LM End	0.81	Issue Type +	Ma	Location *	LS
Category	Earthen Levee			GPS Latitude/Longitude	
				Start	End
Item	Animal Control			38.589531 °	38.589531 °
				-121.432133 °	-121.432133 °
DWR ID	DWR_NA0001_03_s_2017_23				
Comment Code					
A3 : No rodents visible, but rodent burrows visible; need to backfill and compact or grout burrows.					
Inspector Comment					
Rodent burrows at levee toe.

View of the rodent burrow at the levee toe.

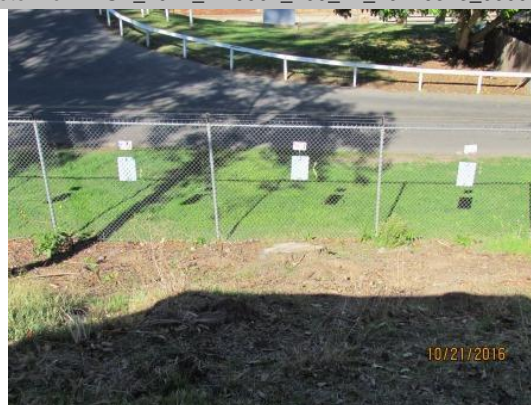
Photo 1 of 1 : SP_2017_NA0001_490_22_20170313_00002.jpg

LM Start	0.91	Rating **	N	Issue No.	22
LM End	0.91	Issue Type +	Ma	Location *	LS
Category	Earthen Levee			GPS Latitude/Longitude	
				Start	End
Item	Trim / Thin Trees			38.589752 °	38.589752 °
				-121.433962 °	-121.433962 °
DWR ID	DWR_NA0001_03_s_2016_22				
Comment Code					
T5 : Tree stumps.					
Inspector Comment

View of the tree stump on the landside levee slope.

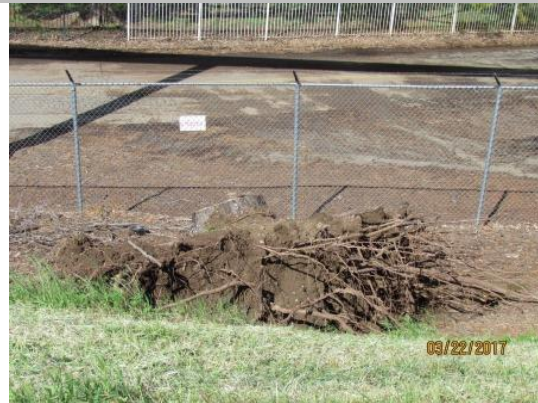
Photo 1 of 1 : SP_2017_NA0001_490_21_20170406_00034.jpg

LM Start	1.04	Rating **	U	Issue No.	21
LM End	1.04	Issue Type +	Ma	Location *	LS
Category	Earthen Levee			GPS Latitude/Longitude	
				Start	End
Item	Trim / Thin Trees			38.590073 °	38.590073 °
				-121.436362 °	-121.436362 °
DWR ID	DWR_NA0001_03_s_2017_21				
Comment Code					
T5 : Tree stumps.					
Inspector Comment					
Remove stump and recompact the area with appropriate levee fill.

View of the tree stump at the levee toe.

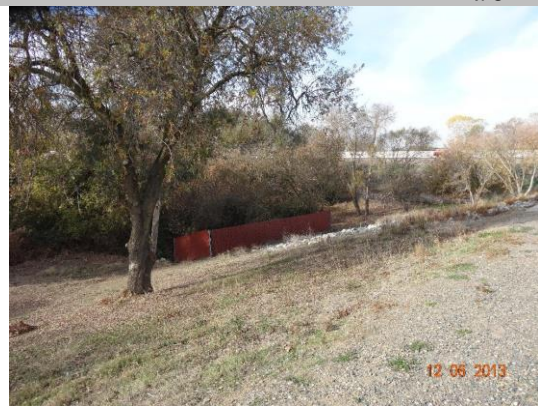
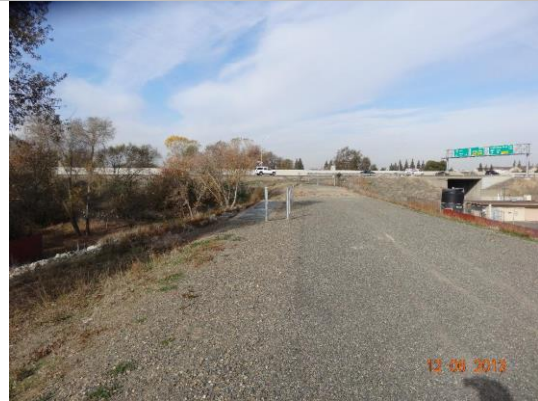
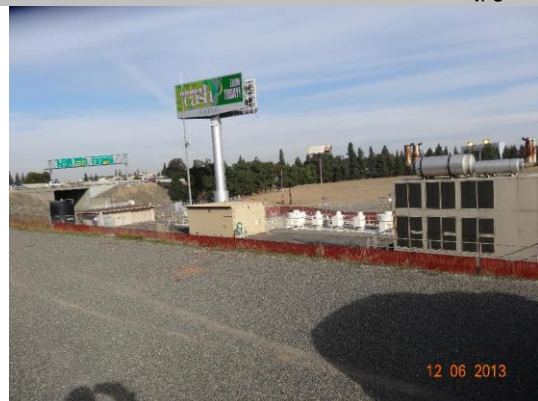
Comment Code					
Inspector Comment					
FS_ID:50047 DS_ID:24292 EP_NO: 5776 Repair Type: Non-Urgent Crossing Status: Found UCIP Comments: 8/11/2016 Issue has been addressed--no hole is present at site. Hole could have been associated with burrow activity. Need to contact owner to obtain internal integrity inspection to confirm pipe is in good condition. Crossing has been changed from Urgent to Non-Urgent due to limited evidence to support leak in pipe. (DWR UCIP - omagana)12/3/2013 Hole present next to concrete vault on levee crown (waterward side). Hole could be sink hole or burrow activity unable to determine. Need to contact owner to determine status of crossing and to investigate hole. (DWR UCIP - omagana) FIELD_STRUCT_DESC: [Drainage Plant No. 2] 7 of 8: 18-inch steel drainage pipe through the levee at an unknown depth below the crown. Metal cutoff wall around pipe under landside (LS) shoulder. Siphon breakers in concrete box located on the waterside (WS) shoulder. Pumping plant at LS toe. Access ramp to pumping plant located on LS. Concrete discharge box located on the WS. Flap gate located on the WS end. Outfall structure located on the WS. (Permit No. 5776, 1972 - American River Flood Control District; name change completed under Permit No. 5776-1, 2016 - City of Sacramento) [Additional Reference(s): DWR Levee Log, 2002] FS Date: 8/11/2016

View of levee crown--concrete vault located on WS shoulder.

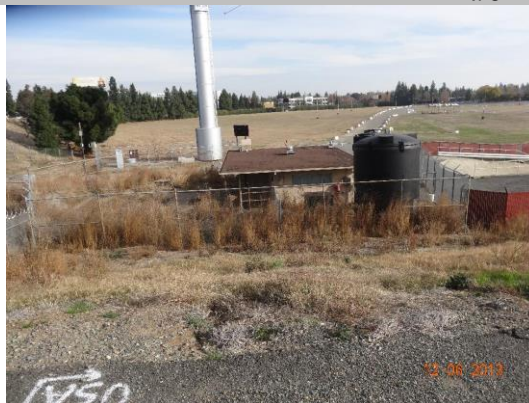
LM Start	1.54	Rating **	M	Issue No.	27
LM End	1.54	Issue Type +	En	Location *	LS
Category	Supplemental			GPS Latitude/Longitude	
				Start	End
Item	DWR UCIP Field Study			38.593290 °	38.593290 °
				-121.443980 °	-121.443980 °
DWR ID					
Comment Code					
Inspector Comment					
FS_ID:31224					
DS_ID:24644					
EP_NO: 2805					
Repair Type: Non-Urgent					
Crossing Status: Indicator Found					
UCIP Comments: Unable to confirm what crossings are going through levee. Will need to coordinate iwth owner to determine active crossings.					
FIELD_STRUCT_DESC: [Arden Treatment Plant] 3 of 4: 34-inch concrete encased sewer pipe through the levee, 7.5 feet below the crown. Concrete cutoff wall around pipe under center of levee. Siphon breaker in housing at waterside (WS) shoulder. Treatment plant on landside (LS).					
FS Date: 12/3/2013

Concrete box located on waterward shoulder.

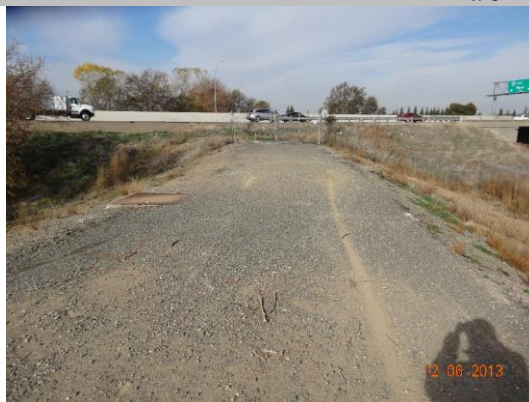
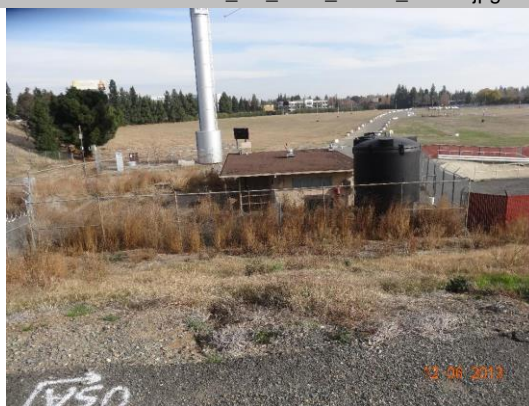
LM Start	1.54	Rating **	M	Issue No.	28
LM End	1.54	Issue Type +	En	Location *	LS
Category	Supplemental			GPS Latitude/Longitude	
				Start	End
Item	DWR UCIP Field Study			38.593290 °	38.593290 °
				-121.443980 °	-121.443980 °
DWR ID					
Comment Code					
Inspector Comment					
FS_ID:31225 DS_ID:24645 EP_NO: 2805 Repair Type: Non-Urgent Crossing Status: Indicator Found UCIP Comments: Unable to confirm what crossings are going through levee. Will need to coordinate with owner to determine active crossings. FIELD_STRUCT_DESC: [Arden Treatment Plant] 4 of 4: 34-inch concrete encased sewer pipe through the levee, 6.2 feet below the crown. Concrete cutoff wall around pipe under center of levee. Siphon breaker in housing at waterside (WS) shoulder. Treatment plant on landside (LS). FS Date: 12/3/2013

View of levee crown and concrete box located on waterward shoulder.

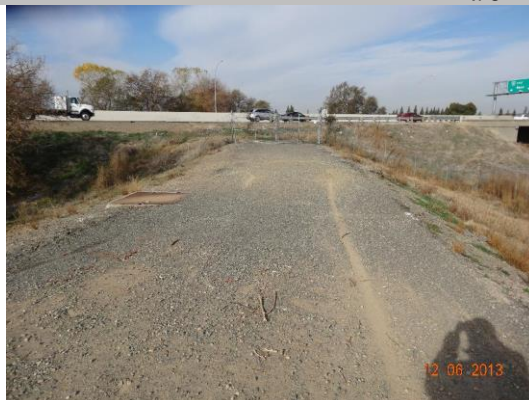
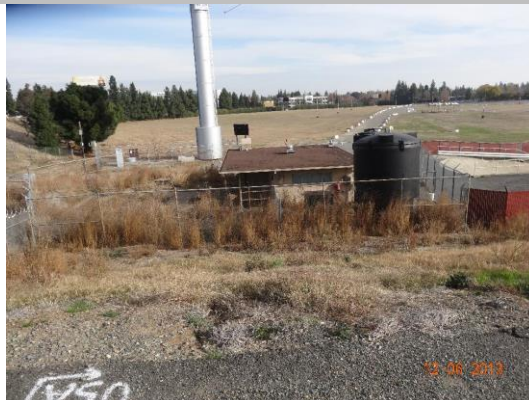
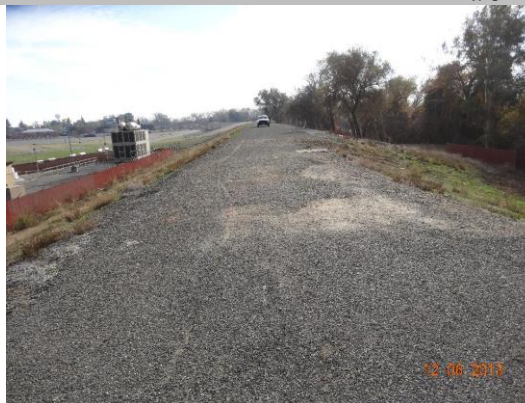
Comment Code					
Inspector Comment					
FS_ID:31227					
DS_ID:24293					
EP_NO: 2805					
Repair Type: Non-Urgent					
Crossing Status: Indicator Found					
UCIP Comments: Unable to confirm what crossings are going through levee. Will need to coordinate with owner to determine active crossings.					
FIELD_STRUCT_DESC: [Co Sanitation District No. 2 Pump Station] 18-					
inch concrete sewer main through the levee, 6 feet below crown.					
Concrete cutoff wall around pipe under center of levee. 2-inch air					
release valve located on waterside (WS) shoulder. Treatment plant on					
landside (LS). Crossing continues under the channel and through the					
opposite levee. (Permit No. 2805-1961)					
FS Date: 12/3/2013

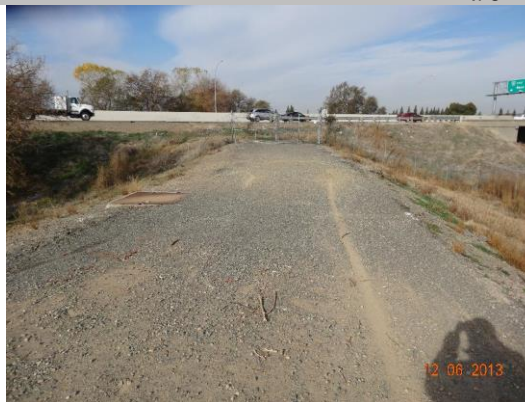
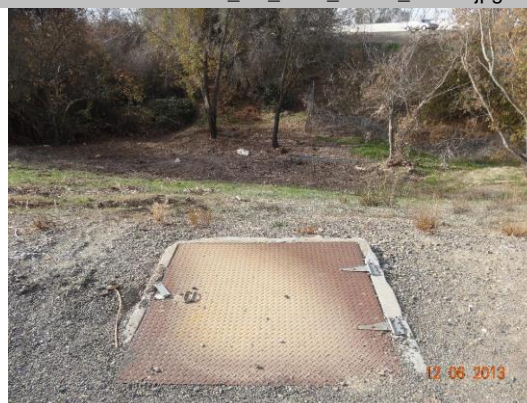
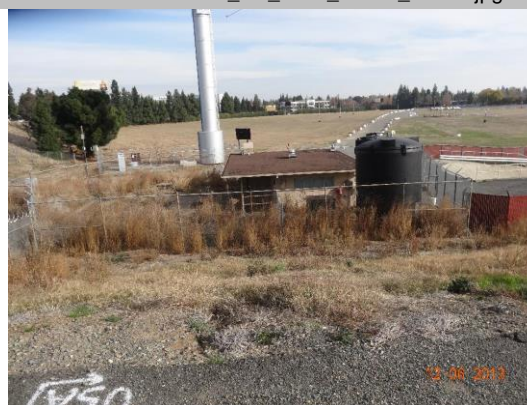
Comment Code					
Inspector Comment					
FS_ID:31223 DS_ID:24643 EP_NO: 2805 Repair Type: Non-Urgent Crossing Status: Indicator Found UCIP Comments: Unable to confirm what crossings are going through levee. Will need to coordinate iwth owner to determine active crossings. FIELD_STRUCT_DESC: [Co Sanitation District No. 2 Pump Station]: 24-inch reinforced concrete sewer main through the levee, 2.5 feet below the crown. Concrete cutoff wall around pipe under center of levee. Siphon breaker in housing at waterside (WS) shoulder. Treatment plant on landside (LS). (Permit No. 6216-1969) Line connects to an existing 18-inch sewer line and 8-inch line installed under permit no. 6216. The line also connects to an existing 24-inch line located on the LS. The 24-inch line on LS parallels the levee for approximately 54 feet and ends at the pump station. FS Date: 12/3/2013

Concrete box located on waterward shoulder.

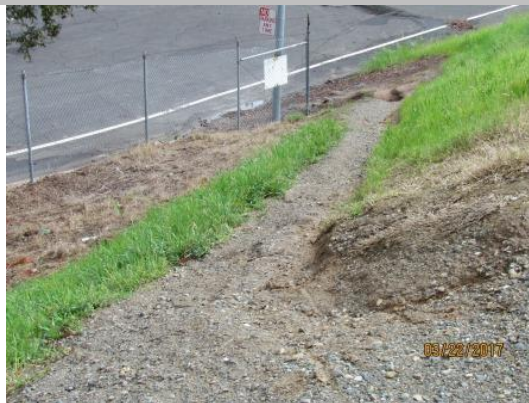
Photo 1 of 1 : SP_2017_NA0001_490_9_20170406_00033.jpg

LM Start	1.82	Rating **	M	Issue No.	9
LM End	1.82	Issue Type +	Ma	Location *	LS
Category	Earthen Levee			GPS Latitude/Longitude	
				Start	End
Item	Slope Stability			38.595700 °	38.595700 °
				-121.448198 °	-121.448198 °
DWR ID	DWR_NA0001_03_s_2012_9				
Comment Code					
S2 : Repair the levee slope damaged by foot traffic and prevent access where possible.					
Inspector Comment

View of the erosion on landside levee slope due to pedestrian traffic.

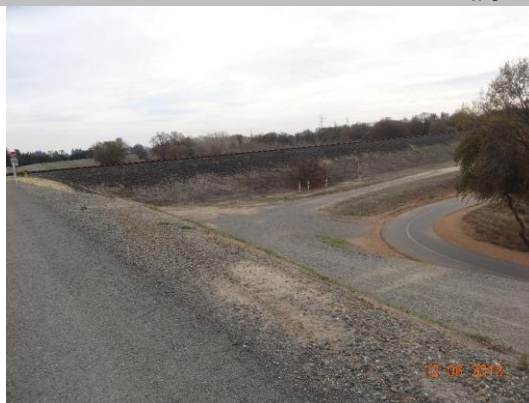
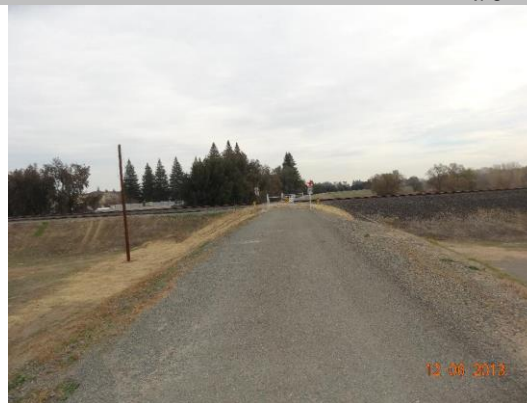
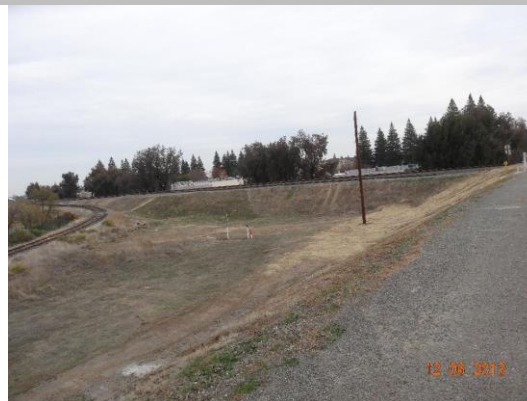
LM Start	1.91	Rating **	M	Issue No.	31
LM End	1.91	Issue Type +	En	Location *	LS
Category	Supplemental			GPS Latitude/Longitude	
				Start	End
Item	DWR UCIP Field Study			38.596096 °	38.596096 °
				-121.449815 °	-121.449815 °
DWR ID					
Comment Code					
Inspector Comment					
FS_ID:31230 DS_ID:24801 EP_NO: N/A Repair Type: Non-Urgent Crossing Status: Found UCIP Comments: No permit found--need to contact owner to determine status of crossing. FIELD_STRUCT_DESC: Gas line through levee at unknown depth. Markers visible on waterside (WS) and landside (LS). Kinder Morgan contact's information is 916-363-1666. FS Date: 12/6/2013

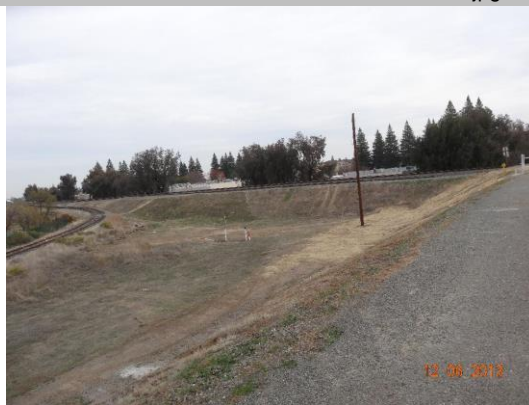
Photo 2 of 3 : UCIP_SP_2017_29826_55134.jpg

LM Start	1.91	Rating **	M	Issue No.	32
LM End	1.91	Issue Type +	En	Location *	LS
Category	Supplemental			GPS Latitude/Longitude	
				Start	End
Item	DWR UCIP Field Study			38.596108 °	38.596108 °
				-121.449887 °	-121.449887 °
DWR ID					
Comment Code					
Inspector Comment					
FS_ID:29826 DS_ID:24294 EP_NO: N/A Repair Type: Non-Urgent Crossing Status: Indicator Found UCIP Comments: Unable to confirm the diameter size or which owner is responsible for crossing. Owner could be Quest Communication or MCI--Need to contact owner to confirm crossing and obtain encroachment permit for work. FIELD_STRUCT_DESC: Communications conduit through the levee at unknown depth. FS Date: 12/6/2013

View of landward side--conduit markers visible.

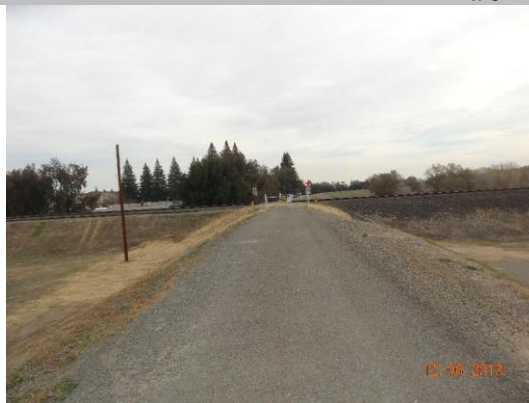
Photo 1 of 3 : UCIP_SP_2017_29827_55141.jpg

LM Start	1.92	Rating **	M	Issue No.	33
LM End	1.92	Issue Type +	En	Location *	LS
Category	Supplemental			GPS Latitude/Longitude	
				Start	End
Item	DWR UCIP Field Study			38.596108 °	38.596108 °
				-121.449887 °	-121.449887 °
DWR ID					
Comment Code					
Inspector Comment					
FS_ID:29827					
DS_ID:24296					
EP_NO: N/A					
Repair Type: Non-Urgent					
Crossing Status: Indicator Found					
UCIP Comments: Unable to confirm the diameter size or which owner is responsible for crossing. Owner could be Quest Communication or MCI--Need to contact owner to confirm crossing and obtain encroachment permit for work.					
FIELD_STRUCT_DESC: 3-inch cable through the levee, 2.5 feet below the crown. Two overhead telephone lines across the levee at location.					
FS Date: 12/6/2013

Overview of levee crown looking upstream at crossing.

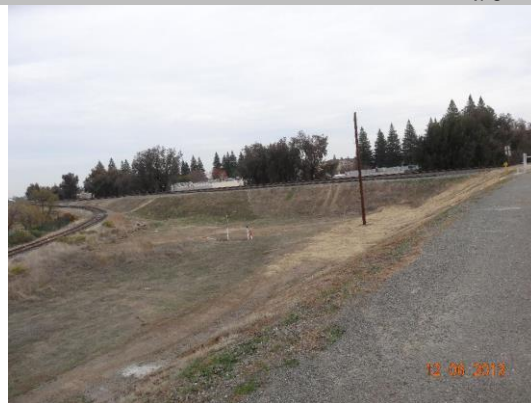
Photo 2 of 3 : UCIP_SP_2017_29827_55140.jpg

LM Start	1.92	Rating **	M	Issue No.	33 (cont)	
LM End	1.92	Issue Type +	En	Location *	LS	
Category	Supplemental			GPS Latitude/Longitude		
				Start	End	
Item	DWR UCIP Field Study			38.596108 °	38.596108 °	
				-121.449887 °	-121.449887 °	
DWR ID						
Comment Code						
Inspector Comment						
FS_ID:29827						
DS_ID:24296						
EP_NO: N/A						
Repair Type: Non-Urgent						
Crossing Status: Indicator Found						
UCIP Comments: Unable to confirm the diameter size or which owner is responsible for crossing. Owner could be Quest Communication or MCI--Need to contact owner to confirm crossing and obtain encroachment permit for work.						
FIELD_STRUCT_DESC: 3-inch cable through the levee, 2.5 feet below the crown. Two overhead telephone lines across the levee at location.						
FS Date: 12/6/2013

Conduit markers visible on landward side.

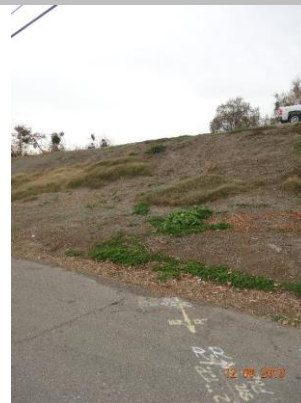
Photo 1 of 3 : UCIP_SP_2017_51311_53391.jpg

Comment Code					
Inspector Comment					
FS_ID:51311 DS_ID:24648 EP_NO: 911 Repair Type: Non-Urgent Crossing Status: Found UCIP Comments: 8/11/2016 Markers found on WS. No markers found on LS. Crossing has been downgraded from Urgent to Non-Urgent, pipe has been marked on WS only. (DWR UCIP - omagana)2/6/2015 Permit information was entered and crossing description updated. (DWR UCIP - omagana)12/3/13 Need to contact owner to determine status of crossing. Markers missing. (DWR UCIP - omagana) FIELD_STRUCT_DESC: 12.75-inch gas line through the levee at unknown depth. Markers found on the waterside (WS) approximately 192 feet and 410 feet from levee crown. No markers found on landside (LS). (line installed under Permit No. 911, 1943 - Pacific Gas and Electric Company [PG&E]) FS Date: 8/11/2016

View of LS slope and USA paint markings indicating alignment.

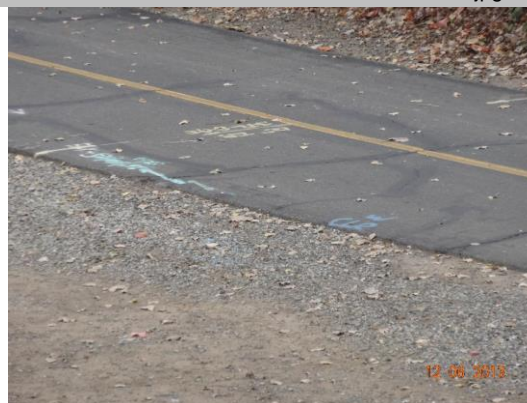
Photo 2 of 3 : UCIP_SP_2017_51311_53390.jpg

Underground service alert (USA) approximate alignment for 12-inch gas line through levee and WS--USA markings on bike path.

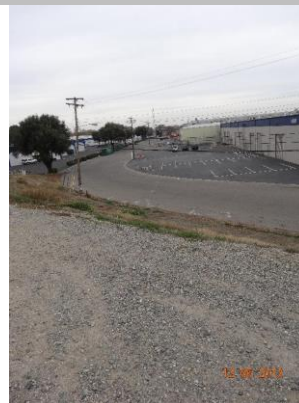
Photo 3 of 3 : UCIP_SP_2017_51311_53389.jpg

Comment Code						
Inspector Comment						
FS_ID:51311 DS_ID:24648 EP_NO: 911 Repair Type: Non-Urgent Crossing Status: Found UCIP Comments: 8/11/2016 Markers found on WS. No markers found on LS. Crossing has been downgraded from Urgent to Non-Urgent, pipe has been marked on WS only. (DWR UCIP - omagana)2/6/2015 Permit information was entered and crossing description updated. (DWR UCIP - omagana)12/3/13 Need to contact owner to determine status of crossing. Markers missing. (DWR UCIP - omagana) FIELD_STRUCT_DESC: 12.75-inch gas line through the levee at unknown depth. Markers found on the waterside (WS) approximately 192 feet and 410 feet from levee crown. No markers found on landside (LS). (line installed under Permit No. 911, 1943 - Pacific Gas and Electric Company [PG&E]) FS Date: 8/11/2016

View of LS with underground service alert (USA) paint with approximate alignment of multiple crossing in general area.

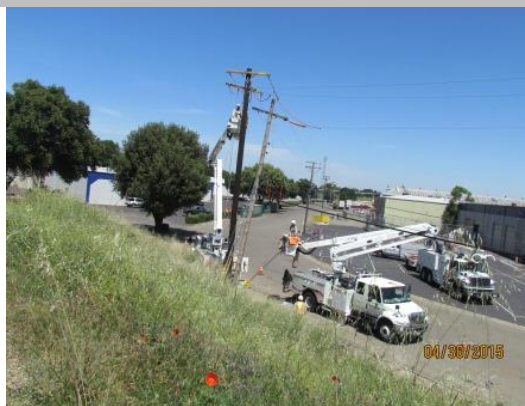
Photo 1 of 1 : SP_2017_NA0001_490_24_20170313_00003.jpg

LM Start	3.31	Rating **	M	Issue No.	24
LM End	3.31	Issue Type +	En	Location *	LS
Category	Earthen Levee			GPS Latitude/Longitude	
				Start	End
Item	Encroachments			38.600958 °	38.600958 °
				-121.471618 °	-121.471618 °
DWR ID	DWR_NA0001_03_s_2015_24				
Comment Code					
PO : Pole					
Inspector Comment					
SMUD replacing old pole at the landside toe of the levee. Pole line does not appear to be permitted.

View of a new pole installed at the landside levee toe.

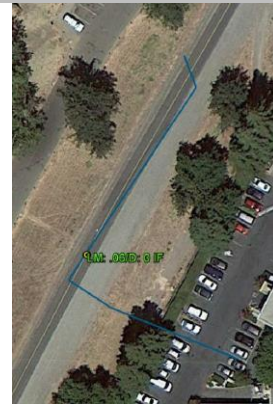
Photo 1 of 3 : UCIP_SP_2017_29003_53405.jpg

LM Start	0.06	Rating **	M	Issue No.	746
LM End	0.06	Issue Type +	En	Location *	LS
Category	Supplemental			GPS Latitude/Longitude	
				Start	End
Item	DWR UCIP Field Study			38.597198 °	38.597198 °
				-121.506532 °	-121.506532 °
DWR ID					
Comment Code					
Inspector Comment					
FS_ID:29003 DS_ID:24344 EP_NO: N/A Repair Type: Non-Urgent Crossing Status: Indicator Found UCIP Comments: Metal boxes located on landward side could be associated with utility -- unable to confirm. Will need to contact owner. FIELD_STRUCT_DESC: Electrical conduit through the levee at unknown depth. FS Date: 12/19/2013

Approximate alignment provided by the City of Sacramento for 2 inch line. Point labelled in green is field verified location where signs of crossing exist.

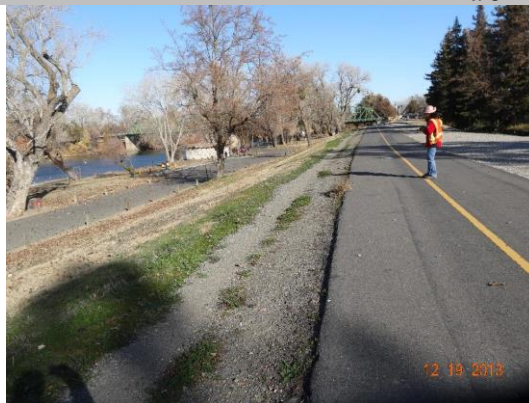
Photo 2 of 3 : UCIP_SP_2017_29003_53404.jpg

LM Start	0.06	Rating **	M	Issue No.	746 (cont)
LM End	0.06	Issue Type +	En	Location *	LS
Category	Supplemental			GPS Latitude/Longitude	
				Start	End
Item	DWR UCIP Field Study			38.597198 °	38.597198 °
				-121.506532 °	-121.506532 °
DWR ID					
Comment Code					
Inspector Comment					
FS_ID:29003 DS_ID:24344 EP_NO: N/A Repair Type: Non-Urgent Crossing Status: Indicator Found UCIP Comments: Metal boxes located on landward side could be associated with utility -- unable to confirm. Will need to contact owner. FIELD_STRUCT_DESC: Electrical conduit through the levee at unknown depth. FS Date: 12/19/2013

Overview of levee crown and waterward side.

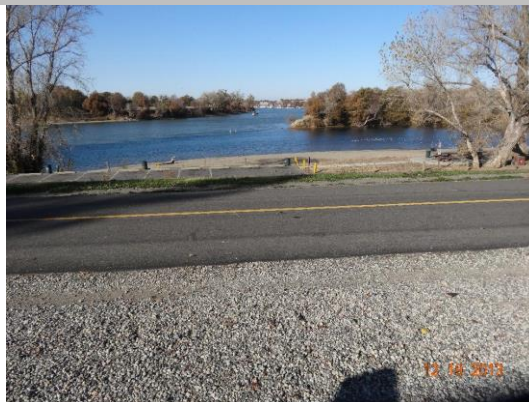
Photo 3 of 3 : UCIP_SP_2017_29003_53402.jpg

View of waterward side.

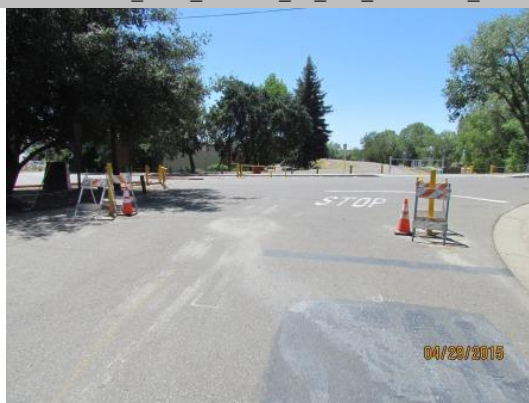
Photo 1 of 1 : SP_2017_NA0001_55_242_20170313_00186.jpg

LM Start	0.20	Rating **	A/W	Issue No.	242
LM End	0.20	Issue Type +	En	Location *	CR
Category	Earthen Levee			GPS Latitude/Longitude	
				Start	End
Item	Encroachments			38.598832 °	38.598832 °
				-121.504984 °	-121.504984 °
DWR ID	DWR_NA0001_04_s_2015_242				
Comment Code					
FE : Fence					
Inspector Comment					
County has obtained a permit from CVFPB 19069 to install gates.

View of the gate installation in progress on the levee crown.

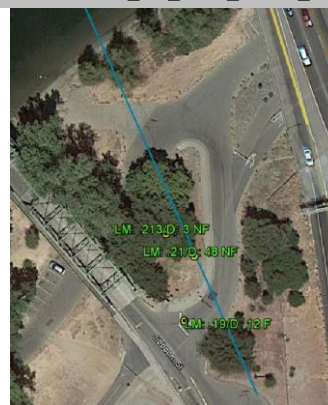
Photo 1 of 1 : UCIP_SP_2017_29006_53414.jpg

LM Start	0.21	Rating **	M	Issue No.	747
LM End	0.21	Issue Type +	En	Location *	CR
Category	Supplemental			GPS Latitude/Longitude	
				Start	End
Item	DWR UCIP Field Study			38.598982 °	38.598982 °
				-121.505045 °	-121.505045 °
DWR ID					
Comment Code					
Inspector Comment					
FS_ID:29006 DS_ID:24435 EP_NO: 17171 Repair Type: Non-Urgent Crossing Status: Not Found UCIP Comments: Unable to find any indications that crossing is still active. Will need to contact owner to determine status of crossing. FIELD_STRUCT_DESC: 48-inch steel water line through the levee, approximately 32.0 feet below the crown. Siphon and blowoff valves in concrete riser on the landside (LS). (Permit No. 17171-2001) FS Date: 12/19/2013

Approximate alignment provided by the City of Sacramento--crossing not found during field visit.

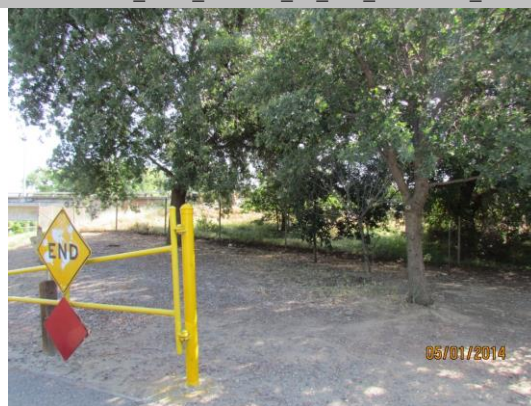
Photo 1 of 1 : SP_2017_NA0001_55_177_20170313_00152.jpg

LM Start	0.21	Rating **	M	Issue No.	177
LM End	0.21	Issue Type +	En	Location *	CR
Category	Earthen Levee			GPS Latitude/Longitude	
				Start	End
Item	Vegetation			38.598980 °	38.598980 °
				-121.504773 °	-121.504773 °
DWR ID	DWR_NA0001_04_s_2012_177				
Comment Code					
V6 : Landscaping					
Inspector Comment					
Landscaping on levee crown at overpass.

View of the landscaping on the levee crown.

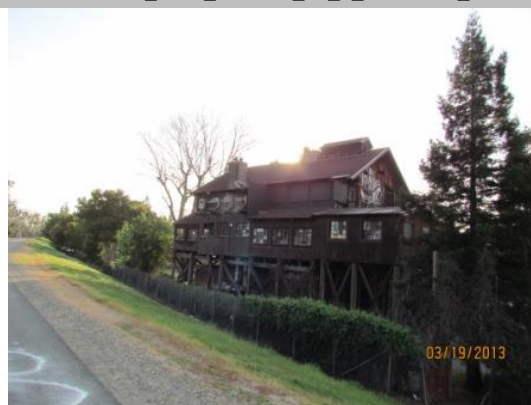
Photo 1 of 1 : SP_2017_NA0001_55_1_20170313_00001.jpg

LM Start	0.31	Rating **	M	Issue No.	1
LM End	0.45	Issue Type +	En	Location *	LS
Category	Earthen Levee			GPS Latitude/Longitude	
				Start	End
Item	Vegetation			38.599835 °	38.600769 °
				-121.503448 °	-121.501133 °
DWR ID	DWR_NA0001_04_s_2012_1				
Comment Code					
V6 : Landscaping					
Inspector Comment					
Vines and privacy fence within 10-ft of the landside toe or on the levee slope obstruct visibility and access.

View of the vines obstructing visibility.

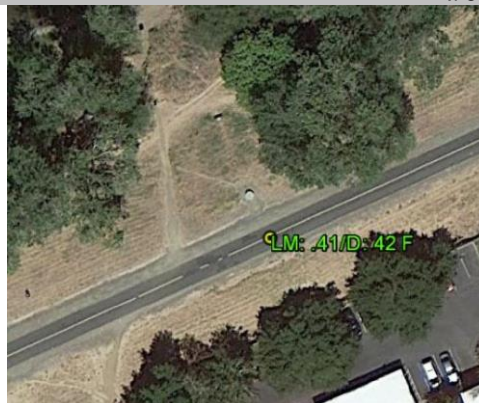
Photo 1 of 3 : UCIP_SP_2017_31249_57212.jpg

Comment Code					
Inspector Comment					
FS_ID:31249					
DS_ID:24303					
EP_NO: N/A					
Repair Type: Non-Urgent					
Crossing Status: Found					
UCIP Comments: Non-functional crossing--need additional information about how crossing was abandoned.					
FIELD_STRUCT_DESC: *ABANDONED* 42-inch corrugated metal (CM) pipe through the levee, 16.5 feet below the crown. Gravel filled with both ends welded shut. Flap gate on the waterside (WS) end. Slide gate in CM riser and splash board drain structure on the landside (LS). (USACE-1955). This entry matches the Drainage or Irrigation Structure referenced in O&M manual (Station 10+00).					
FS Date: 12/19/2013

Overview of crossing location.

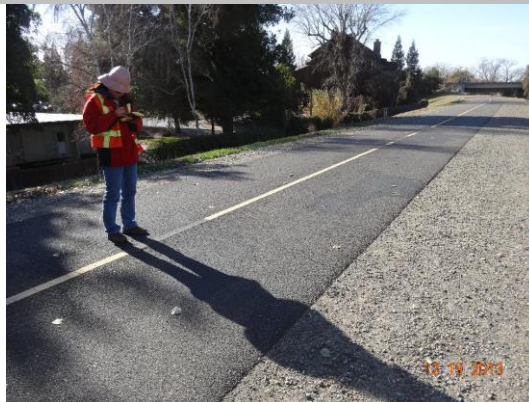
Photo 2 of 3 : UCIP_SP_2017_31249_57209.jpg

View of levee crown at this location.

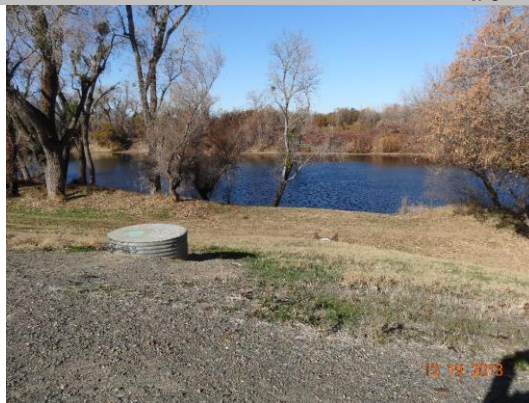
Photo 3 of 3 : UCIP_SP_2017_31249_57210.jpg

LM Start	0.40	Rating **	M	Issue No.	748 (cont)	
LM End	0.40	Issue Type +	En	Location *	LS	
Category	Supplemental			GPS Latitude/Longitude		
				Start		End
Item	DWR UCIP Field Study			38.600436 °		38.600436 °
				-121.502058 °		-121.502058 °
DWR ID						
Comment Code						
Inspector Comment						
FS_ID:31249 DS_ID:24303 EP_NO: N/A Repair Type: Non-Urgent Crossing Status: Found UCIP Comments: Non-functional crossing--need additional information about how crossing was abandoned. FIELD_STRUCT_DESC: *ABANDONED* 42-inch corrugated metal (CM) pipe through the levee, 16.5 feet below the crown. Gravel filled with both ends welded shut. Flap gate on the waterside (WS) end. Slide gate in CM riser and splash board drain structure on the landside (LS). (USACE-1955). This entry matches the Drainage or Irrigation Structure referenced in O&M manual (Station 10+00). FS Date: 12/19/2013

View of waterward side--standpipe located on waterward slope.
Standpipe filled with concrete.

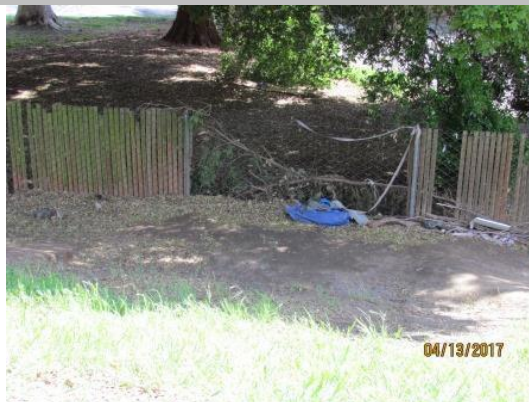
Photo 1 of 1 : SP_2017_NA0001_55_267_20170417_00280.jpg

View of the slope damaged by transients digging in the levee slope.

LM Start	0.53	Rating **	M	Issue No.	267
LM End	0.53	Issue Type +	Ma	Location *	LS
Category	Earthen Levee			GPS Latitude/Longitude	
				Start	End
Item	Slope Stability			38.601163 °	38.601163 °
				-121.499866 °	-121.499866 °
DWR ID	DWR_NA0001_04_s_2017_267				
Comment Code					
S2 : Repair the levee slope damaged by foot traffic and prevent access where possible.					
Inspector Comment

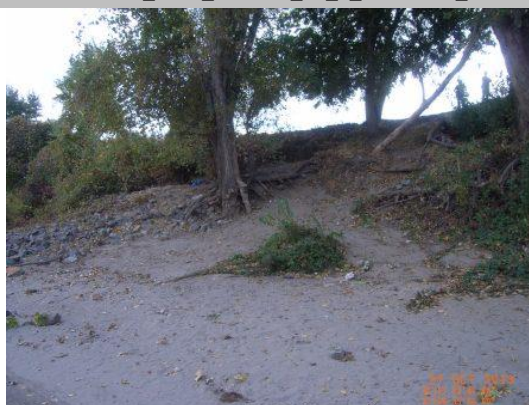
Photo 1 of 1 : SP_2017_NA0001_55_7_20170313_00008.jpg

LM Start	1.61	Rating **	M	Issue No.	7
LM End	1.65	Issue Type +	Ma	Location *	WS
Category	Supplemental			GPS Latitude/Longitude	
				Start	End
Item	2015 USACE Erosion Survey, DRAFT			38.599095 °	38.598791 °
				-121.480337 °	-121.479799 °
DWR ID	DWR_NA0001_04_s_2016_7				
Comment Code					
Inspector Comment					
2012 - Located just downstream of older repair. Failing rock at the upstream end. Erosion of the bank has exposed large tree roots. 2015: No observed changes. [2015 Site ID: LAR_1-8_L]

USACE 2013 Photo #1

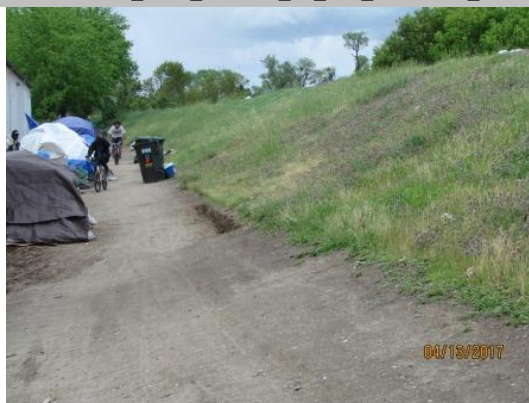
Photo 1 of 1 : SP_2017_NA0001_55_266_20170417_00278.jpg

View of the levee toe cut by the transients.

LM Start	1.80	Rating **	M	Issue No.	266
LM End	1.80	Issue Type +	Ma	Location *	LS
Category	Earthen Levee			GPS Latitude/Longitude	
				Start	End
Item	Slope Stability			38.596876 °	38.596876 °
				-121.478390 °	-121.478390 °
DWR ID	DWR_NA0001_04_s_2017_266				
Comment Code					
S2 : Repair the levee slope damaged by foot traffic and prevent access where possible.					
Inspector Comment
